OBSERVATIONS OF MECHANICALLY POLISHED
KCl SURFACES USING SCANNING ELECTRON
MICROSCOPY

Charles V. Collins, et al

Air Force Cambridge Research Laboratories
L. G. Hanscom Field, Massachusetts

7 August 1974

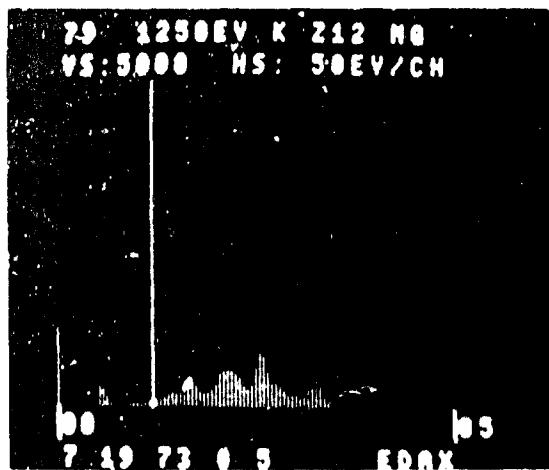
Figure 9. X-ray Analysis of Foreign Matter "B". No magnesium present

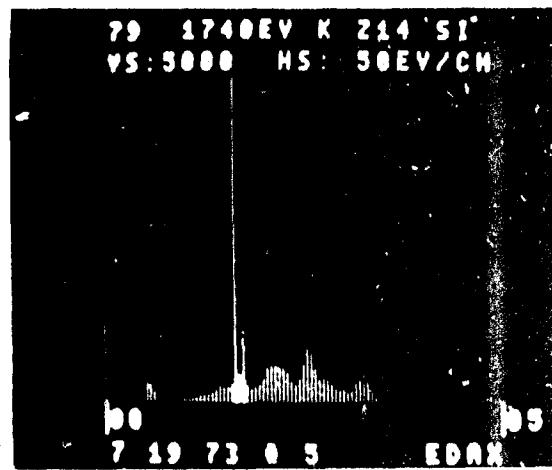
Figure 10. Silicon Lines Identified on Same Spectrum as Figure 9. Other peaks are Au, K, and Cl

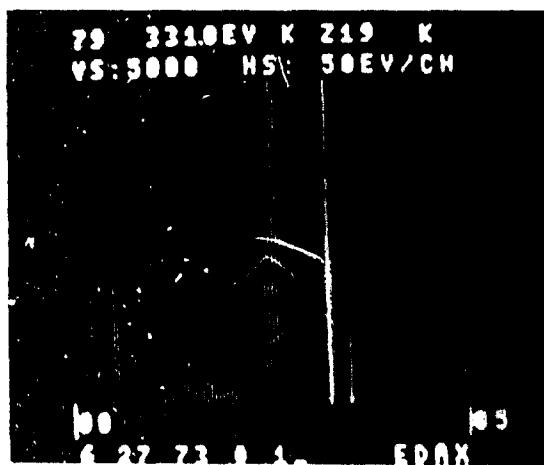
Figure 11. X-ray Spectra of Sample No. 1 with K and Cl Lines Identified

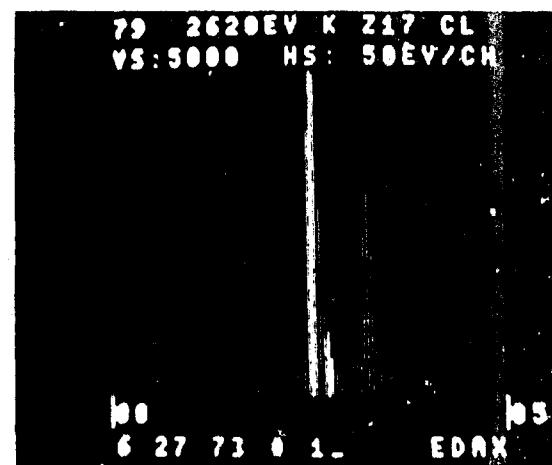
Figure 12. Additional Lines (Al, Au, Si) Identified on Spectrum for Sample No. 1

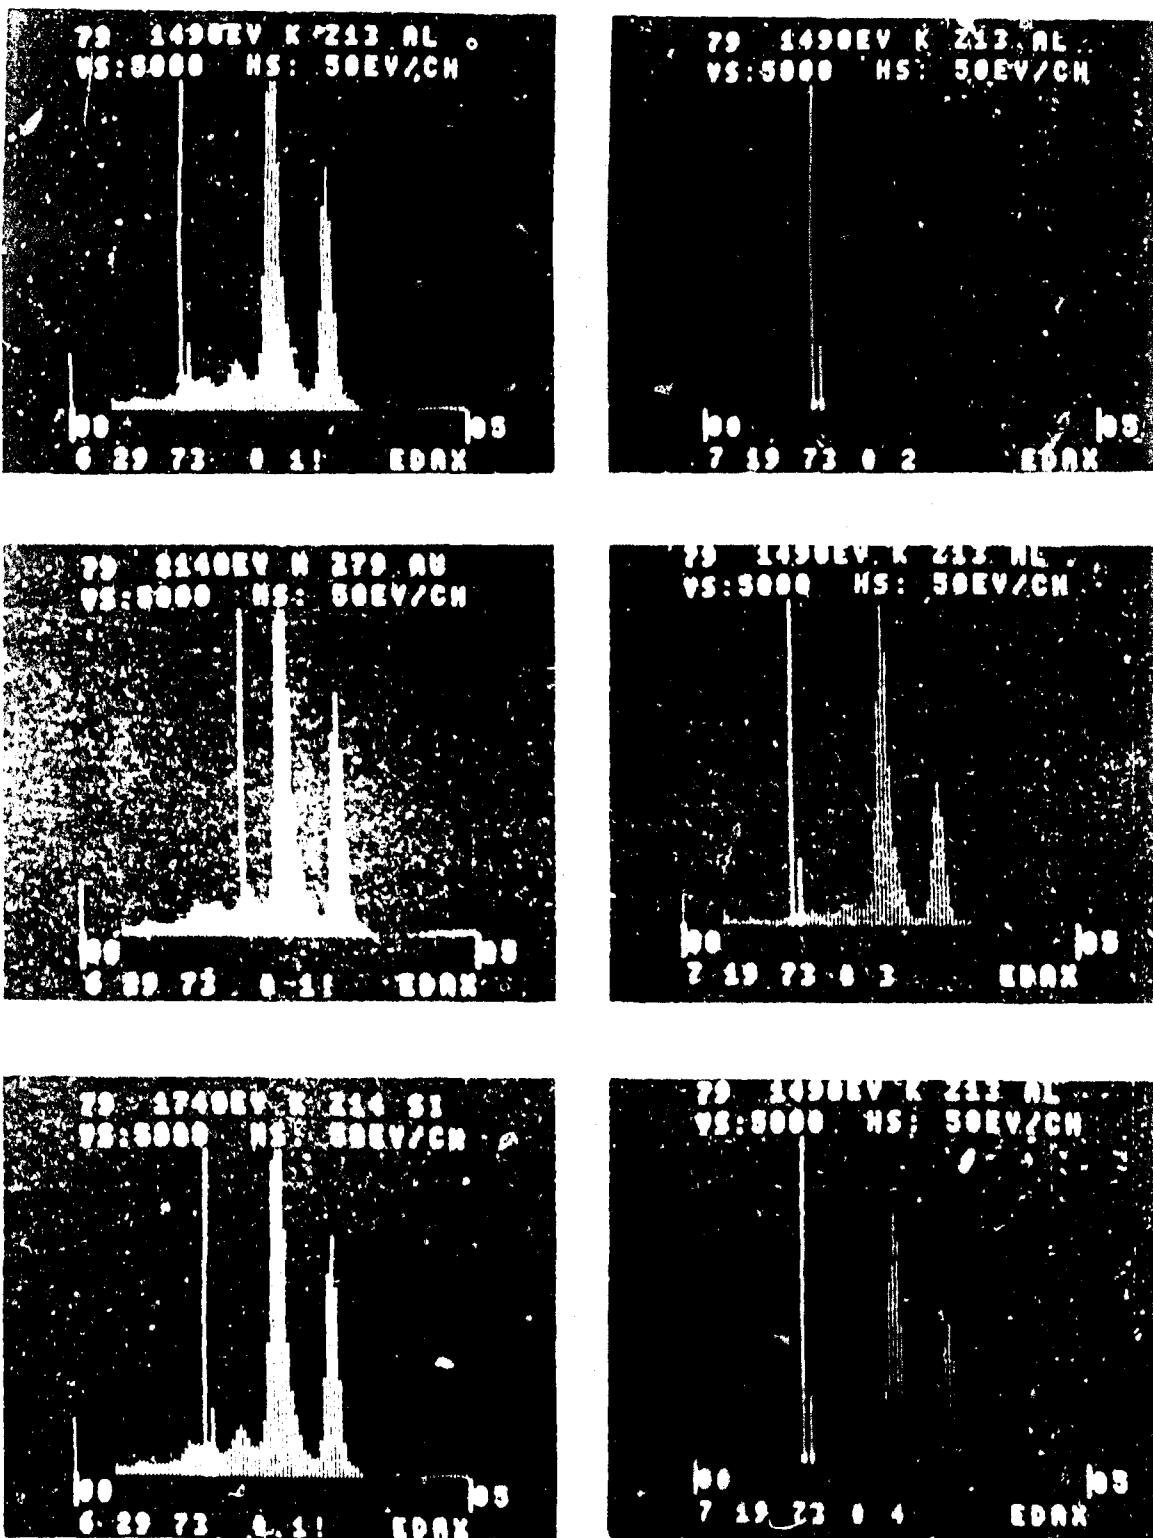
Cracks, gouges, and areas near the edge of the sample retained polishing remnants the easiest. The aluminum concentration was much lower, varying from 0.02 to 0.66 weight percent for these samples. The largest amount of Mg detected was 2.36 percent by weight on sample 5. These numbers merely indicate the range of values observed with the microprobe. It is particularly apparent that large grit material, such as the SiC, may leave large pieces of material embedded in the surface. These foreign bodies will probably cause havoc when a coat is laid down on the surface. Not only will points of stress occur, but also adhesion, optical absorption, thermal conductivity, and other coating properties will be affected by the presence of this "foreign" element in the coating.

Figure 13. Al Lines Identified on Spectra for Samples No. 2, 3, and 4. Trace amounts of aluminum are present.

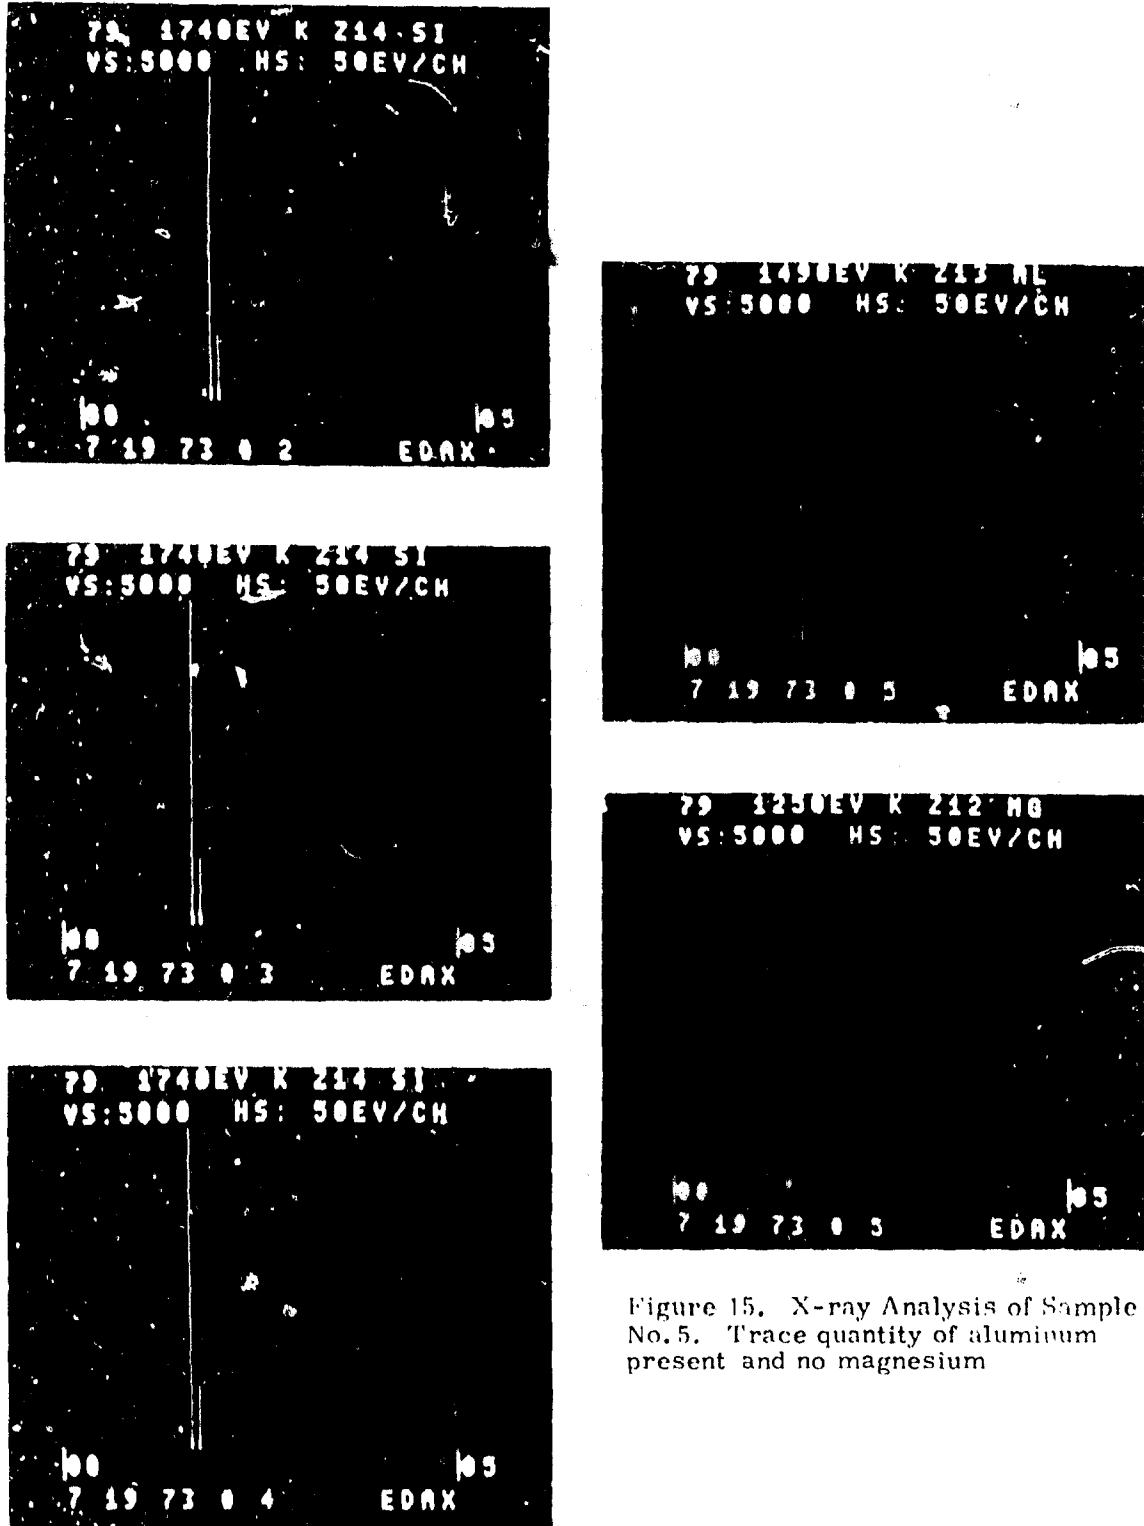
still present on the surface. Studies with the microprobe indicate weight percents varying from 0.04 to 23.25 percent of Si, depending on the area investigated.

Figure 14. Si Lines Identified on Spectra for Samples No. 2, 3, and 4. Trace amounts of silicon are present

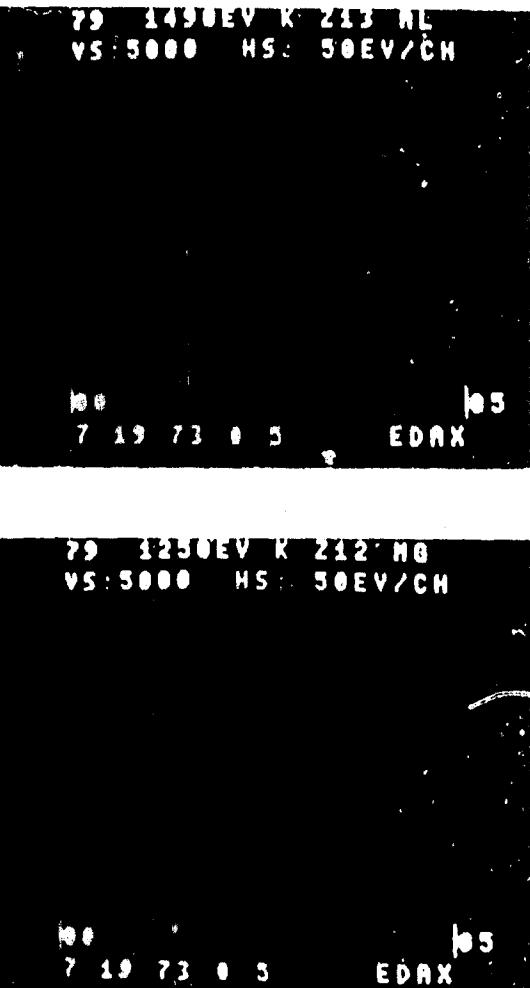
Figure 15. X-ray Analysis of Sample No. 5. Trace quantity of aluminum present and no magnesium
